Customer	: CC-DAR01 Dart Aerospace Ltd.	Drawing Name	: REWORK
Job Number	: 39663		
Estimate Number	: 10804		
P.O. Number	:	Part Number	: D3276041
This Issue	: 03/06/2008 S.O. No. :	Drawing Number	: NCR08-053
Prsht Rev.	: NC	Project Number	:
First Issue	: // Type : SMALL /MED FAB	Drawing Revision	:
Previous Run	: 39662	Material	:
Written By	:

Baffle Assembly LH

Qty(22) D3276-041 Baffle Assembly. The joggled tab was bent in the opposite direction from the dwg. They were all reworked to the correct the joggle (re-bent opposite). The grain directions are all at 45 degrees (not vertical per dwg). They were bent while powder coated, so it's impossible to inspect the surface of the aluminum in their current state. One baffle cracked during re-bending.

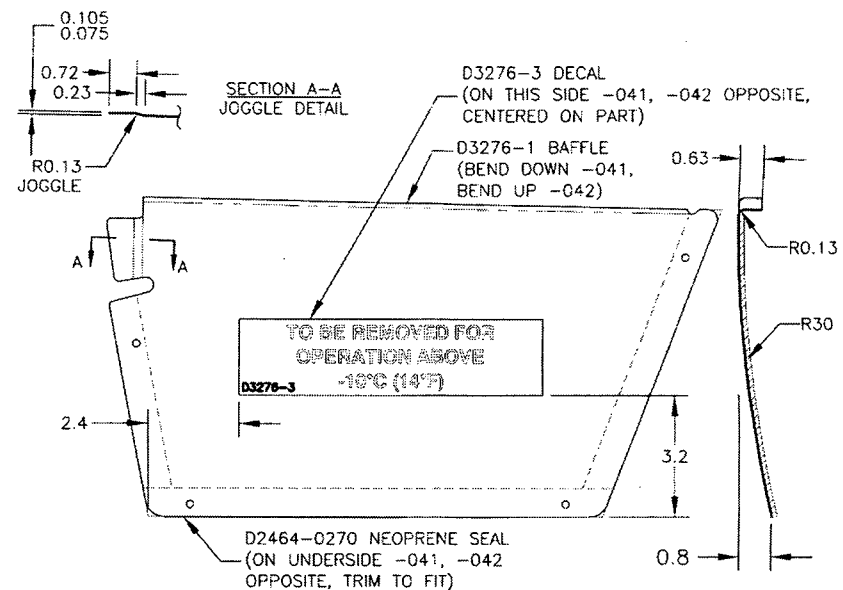
D3276-041 BAFFLE ASSEMBLY, LH (SHOWN) D3276-042 BAFFLE ASSEMBLY, RH (BEND/JOGGLE OPPOSITE)

I would be inclined to accept these parts. As you mention, they will not be under any load. Also, if the tab breaks off, I have checked with Harvey, and it will fall into an area of the R44 helicopter where it will not cause any damage.

Since they were re-bent after powder, could you do an LPI to check for cracks rather than a powder removal. If the metal is cracked, the paint will also be cracked, right? If not, perhaps you could spot check a couple for cracks?

The part is bolted in, the tab is unlikely to be under any significant stress. However, I'm thinking they should maybe strip the parts (at least locally) to inspect the surface for cracks, especially since one cracked during re-bending. That probably won't be popular....

Comment: SMALL & MEDIUM FAB RESOURCE 1
 REWORK PER DRWG AND NCR08-053

DATE	STEP	Description of NC Section A	Corrective Action Section B			Verification Section C	Approval Chief Eng	Approval QC Inspector
			Initial Chief Eng	Action Description Chief Eng	Sign & Date			
080701	3.0	1 part cracked while re-benching. <i>BR</i>	<i>ASIAN</i>	Scrap: des tral	<i>mt</i> 08-07- 02	<i>080701</i>	<i>ASIAN</i>	<i>080701</i>
